## Analysis of the kiln drying process of a sawmill in Espírito Santo state, Brazil: a case study

Djeison Cesar Batista\*<sup>1</sup>, Vinicius Munaldi Lube<sup>1</sup>, João Gabriel Missia da Silva<sup>1</sup>, Jairo Barbieri Rodrigues da Vitória<sup>1</sup>

The objective of this work was to analyze the process of kiln drying of wood in a selected mill located in the Espírito Santo state, Southeastern Brazil.

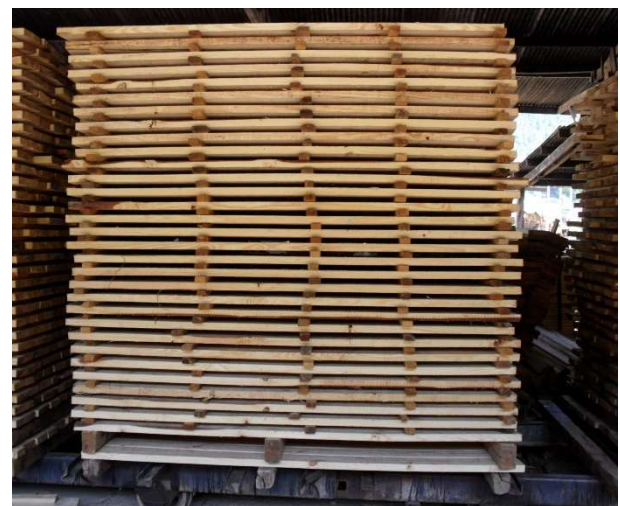
The lumber stacks were prepared with the following composition: one layer of bolsters, supported on the base of the kiln trucks; 31 layers of stickers and 32 layers of boards (laid side by side, with no spaces between the boards), resulting in dimensions 1,700 x 1,810 x 2,200 mm (width x height x length). All the characteristics of the lumber stacks that have been discussed can be seen in Figure 1, showing a representative lumber stack.

Figure 1. Representative lumber stack of the mill.

The lumber was stacked without any type of restriction to minimize dimensional movement of boards on the upper layers. Although the kiln trucks have structures for supporting the lumber stacks ("I" shaped welded to the base), they were significantly damaged, as mentioned, which required an adaptation using bolsters to give support to the stacks. Operators assembled a layer of bolsters, followed by another of boards (not from the drying process), and then mounted the lumber stack itself, starting with another layer of bolsters.

The distance between the stickers and therefore their number per layer (between 400 and 800 mm) was according to what was proposed by Hildebrand (1970) for 30 mm thick boards. However, the alignment between the stickers of different layers was variable, which can cause destabilization of the lumber stack, and warping during the drying cycle.

Another negative aspect of the stacking was the uneven number of bolsters (three) at the base of the lumber stack and stickers (five) between layers, which may also cause deformation in the boards during stacking and warping during drying. This was also one of the major stacking problems noted by Anjos et al. (2011).

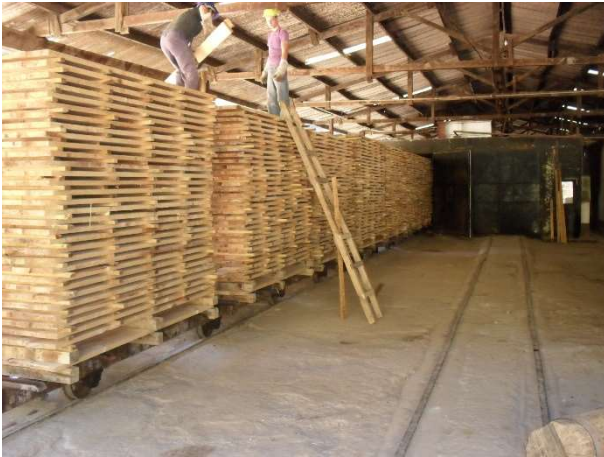
capacity (three kilns). A complete kiln charge is shown in Figure 2, just moments before being placed in one of the kilns.

**Figure 2.** General view of the drying sector during the preparation prior to loading.

The lumber stacks were placed in the kiln trucks with the same tractor, and when necessary, stacks would be manually reorganized, particularly the upper layers (Figure 2). After that, the kiln trucks were slowly pushed into the chamber by the tractor. It is noteworthy that a horizontal gap of about 500 mm was left between the ends of the lumber stacks (tops of boards), which causes problems in the air circulation, reducing the kiln capacity and thus the productivity of dried lumber.
