CHALLENGES IN DISASTER ARCHAEOLOGY: FORENSIC AND ARCHAEOLOGICAL APPROACHES IN THE RESCUE OF HUMAN REMAINS FROM THE BIOLOGICAL ANTHROPOLOGY TECHNICAL RESERVE OF THE NATIONAL MUSEUM/UFRJ (BRAZIL)

At the fire of September 2018, all the Biological Anthropology collections of the National Museum were deeply affected. Located on the third floor, the technical reserve collapsed and was partially buried by debris. The original location of each human remains was lost and their respective identification, formerly written directly in the bones, was also erased by the burning process. Following the ethical code for human remains, especially those musealized, the rescue efforts employed forensic and archaeological methods to enhance the chances of future identification and, most importantly, to rescue the surviving remains. In this vein, the excavation and documentation process collected the majority of the remains encapsulated and protected by surrounding sediment. Construction debris, furnishings, equipment and specially the cabinet that housed the collections were documented and identified to understand the dynamic of fire and collapse process, and how the remains were affected and scattere

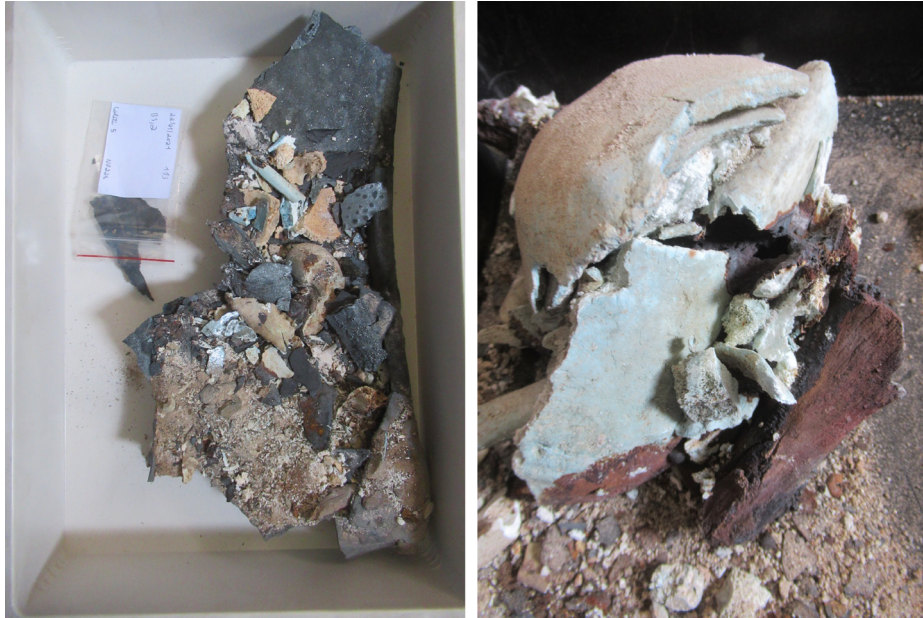
the middle of the room; no residual material from the boxes was found upon first inspection. The range of different colors found in the bones most likely shows how they were exposed to different temperatures. Shades of light blue, yellow, and white were sometimes found in the same bone fragment or in fragments next to each other (Figure 2).

Figure 2: Bone fragments, with different colors, stuck in metal from the sliding cabinet (source: Luísa Faria).

A surprising discovery during the rescue was bones that had absorbed metal. Due to the high temperatures, the metal from the cabinet melted and was fully absorbed by the bones in contact with it. Once the metal cooled, the bones retained their shape, although their color and weight had changed, as they were now infused with metal. Most fragments that absorbed the metal only showed a few stains, while others became heavy and completely darkened. It was not possible to determine, just by looking, how deeply the metal had penetrated the bone—we could only estimate based on its weight.

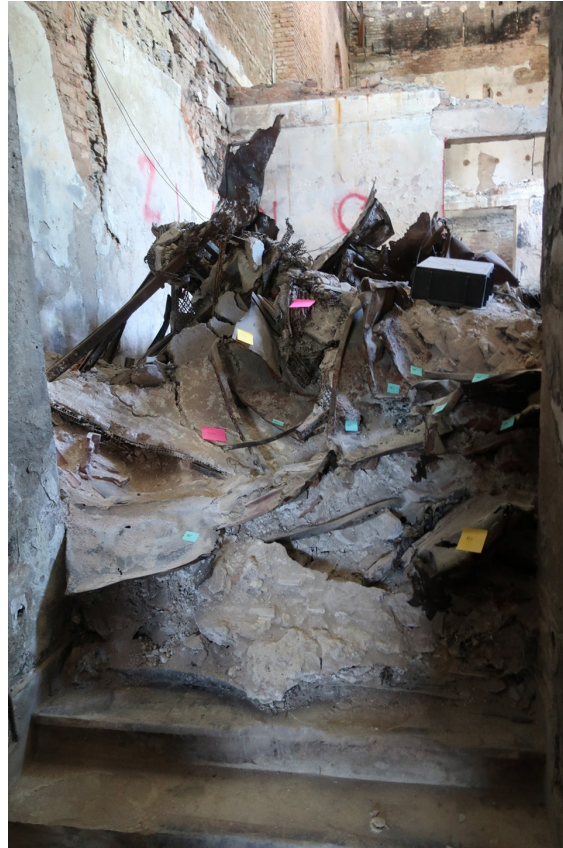
human remains. One notable find was the shelves of cabinets and compact shelving units that had become completely twisted and impregnated with bone fragments. Whenever a large quantity of bone remains was found, the shelves were removed and preserved for in-depth laboratory analysis. Figure 3, which depicts this area, shows the identified shelves and building materials, providing a valuable methodological record. Conventional manual archaeological excavation methods were employed.

Figure 3: Identification of shelves for subsequent extraction and excavation (source: Marina Buffa César).

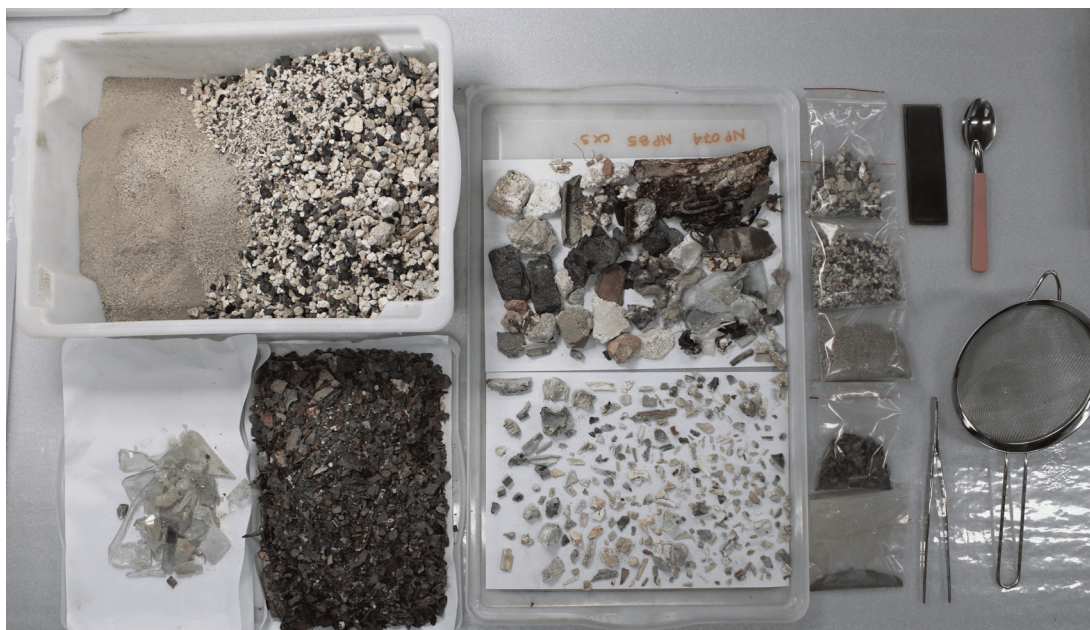
The inventory process started in the second semester of 2023, and involved sifting through each box, carefully searching for every fragment, and collecting samples of each type of debris present to characterize the surrounding sediment (Figure 4). Analysis of the remains and mapping of heat modification started in 2024, being conducted in parallel to the inventory.

Figure 4: Example of detailed processing of collected fragments encased in debris and sediment (source: Mônica Dias).
